CARTER LAKE
IOWA AND NEBRASKA

STREAMBANK EROSION CONTROL TECHNICAL ASSISTANCE
SECTION 55 AUTHORITY

U.S. ARMY ENGINEER DISTRICT, OMAHA
CORPS OF ENGINEERS
OMAHA, NEBRASKA

May 1985

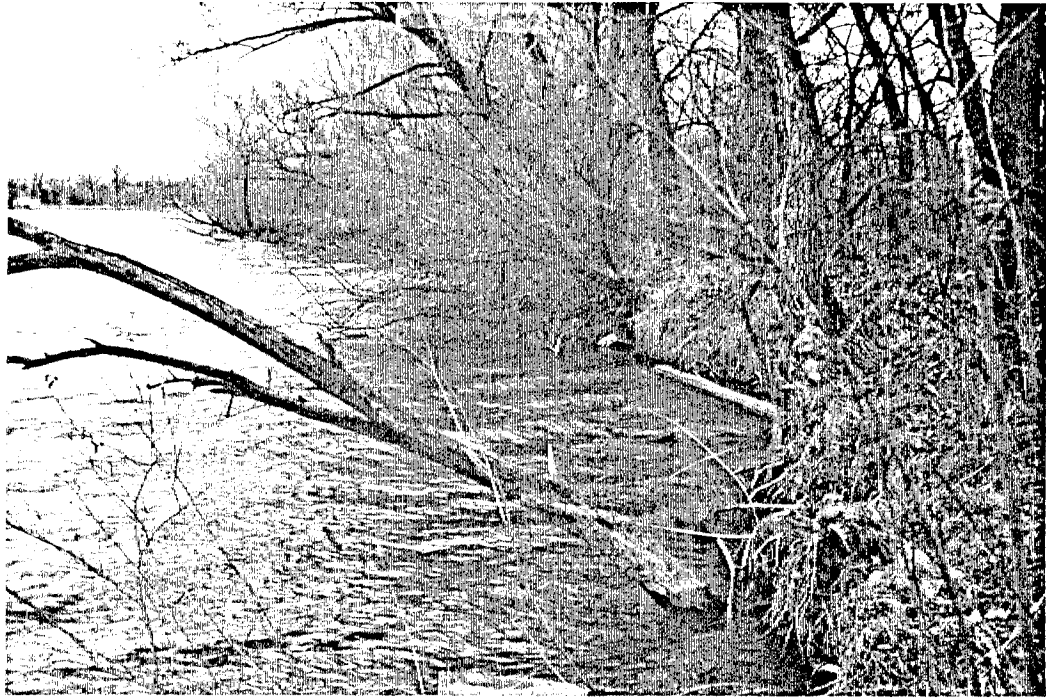
1. Looking north from near south end of east shore area. Erosion not active as evidenced by grass and tree growth up to water's edge, but persistent enough that in time trees fall into lake. Lake elevation 970.3.

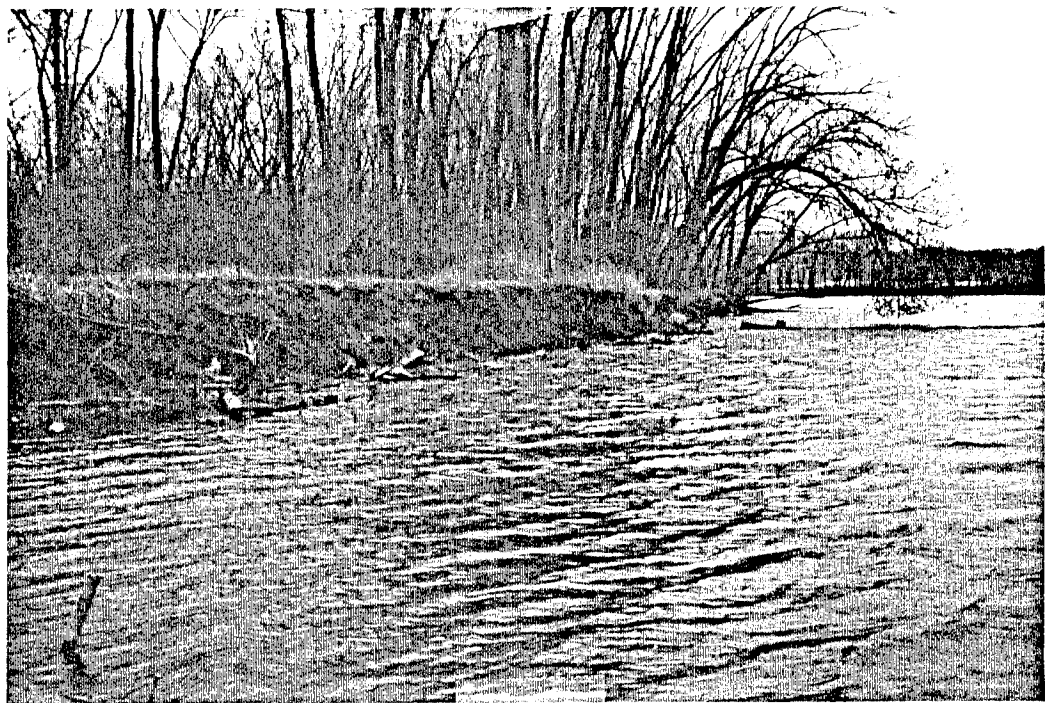
2. Looking SW at active erosion near northern end of area of concern.

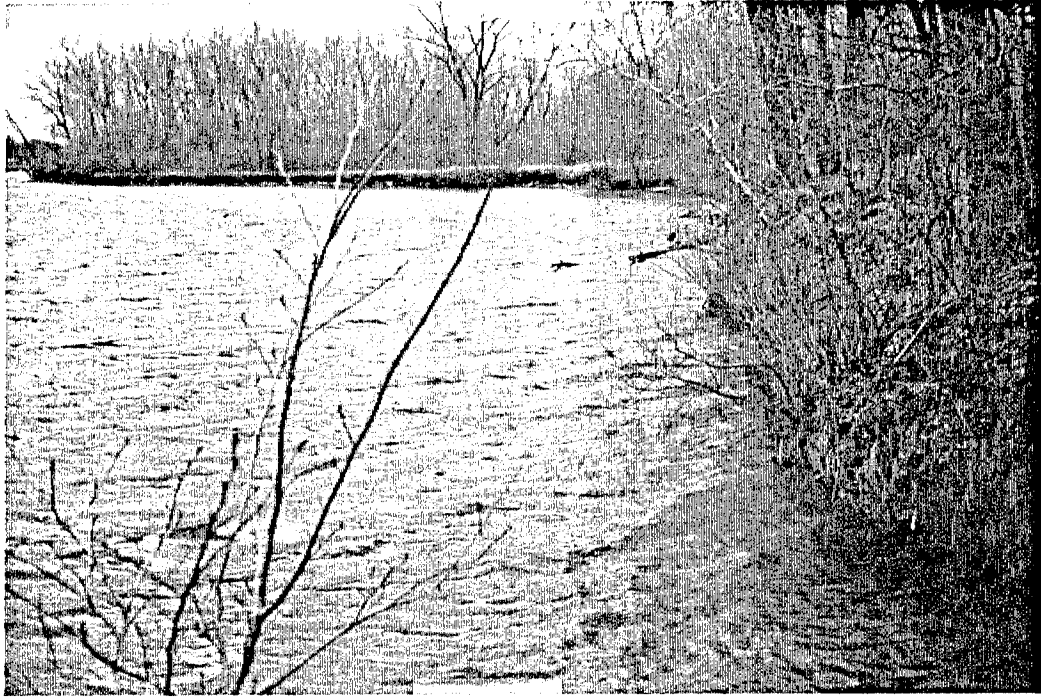
3. Looking NE at area of active erosion in background.
Heavy tree growth along shore is typical for Iowa side.

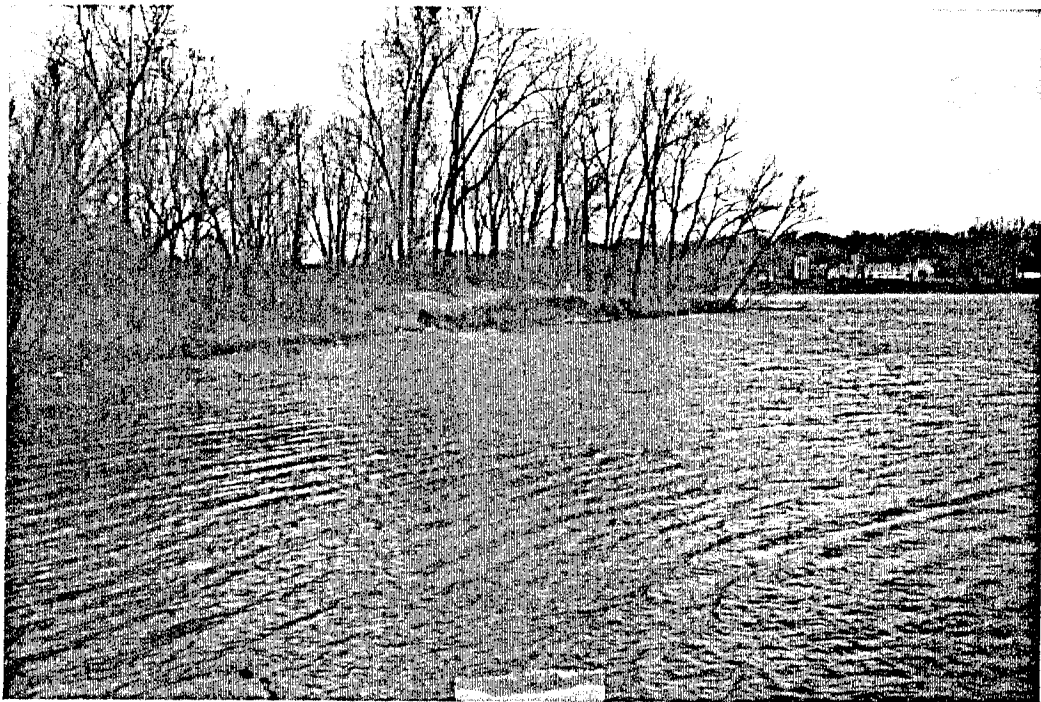
4. Looking SW at areas of slight erosion adjacent to area
of active erosion. Nowhere along Iowa shoreline are
there structures or other facilities threatened by erosion.

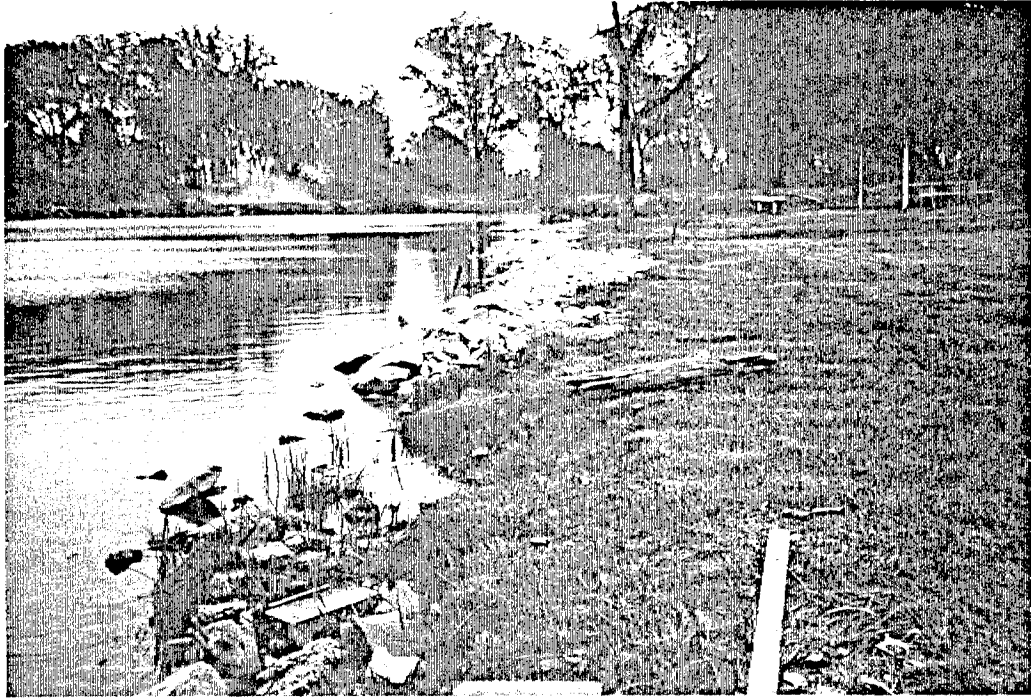
5. Typical quarried rock windrow looking east along south shore of west leg of lake. This is a smaller section than proposed in this report.

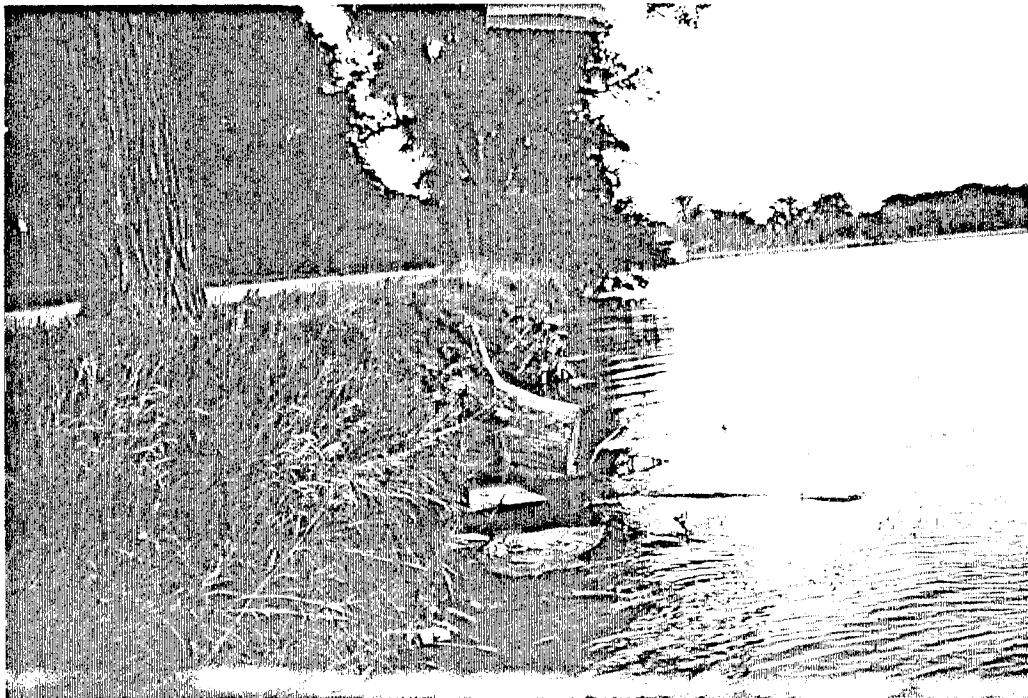
6. Typical active erosion looking north along west shore of west leg of lake. Public access road immediately to left of erosion and mature trees.

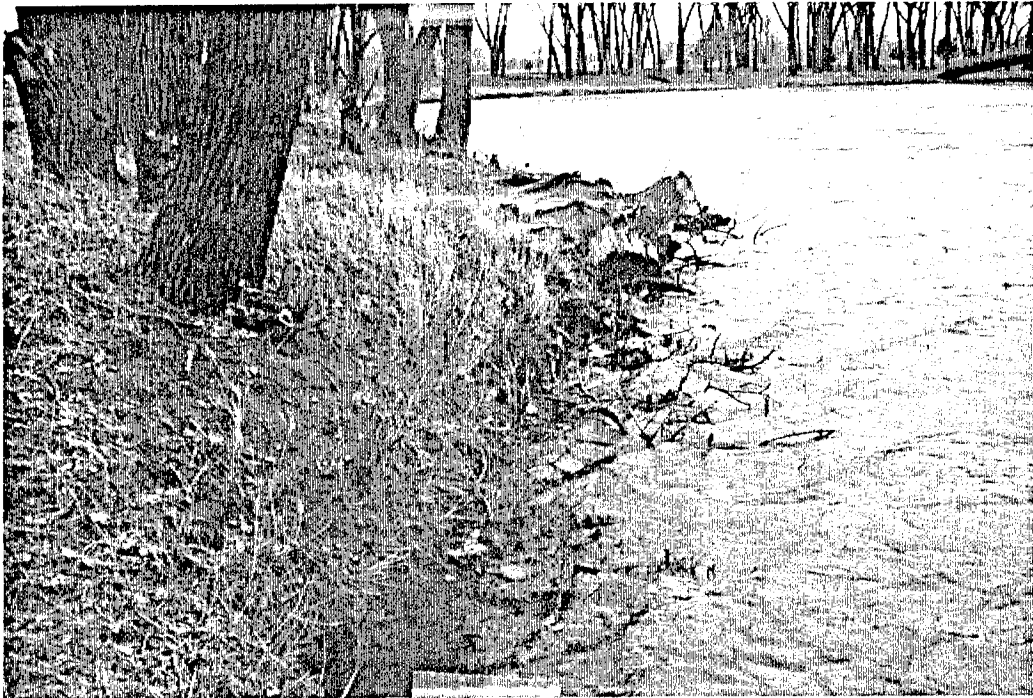
7. Looking SW at very slight but persistent erosion near southern end of east leg of Carter Lake. Future erosion considered to be slow.

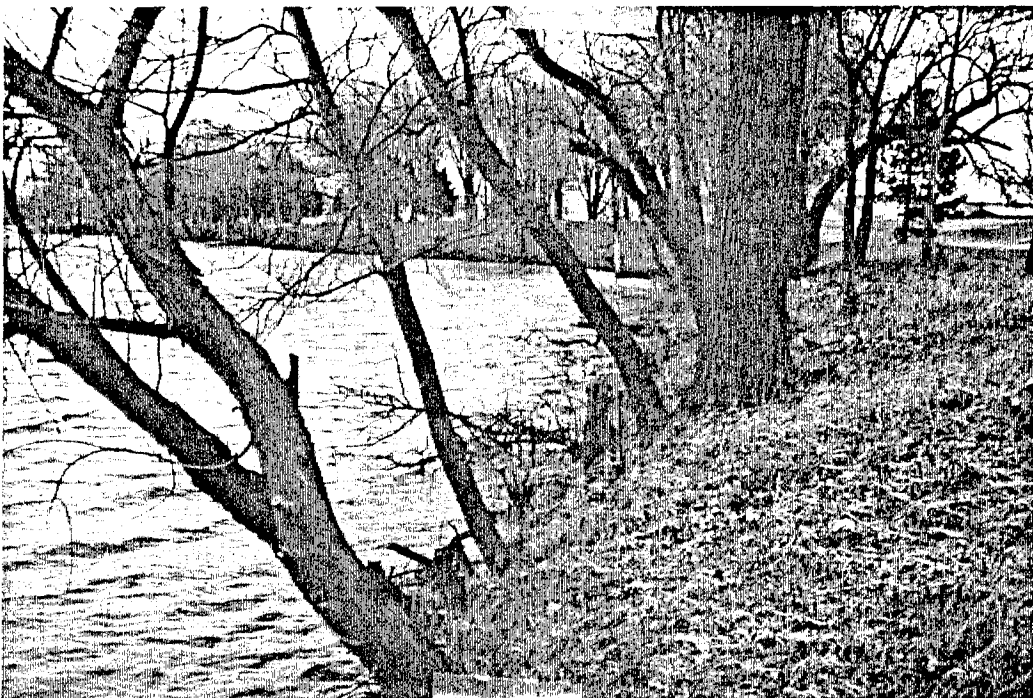
8. Looking NW from same location as Photo 7. Erosion slow and not considered to be area of concern at present.

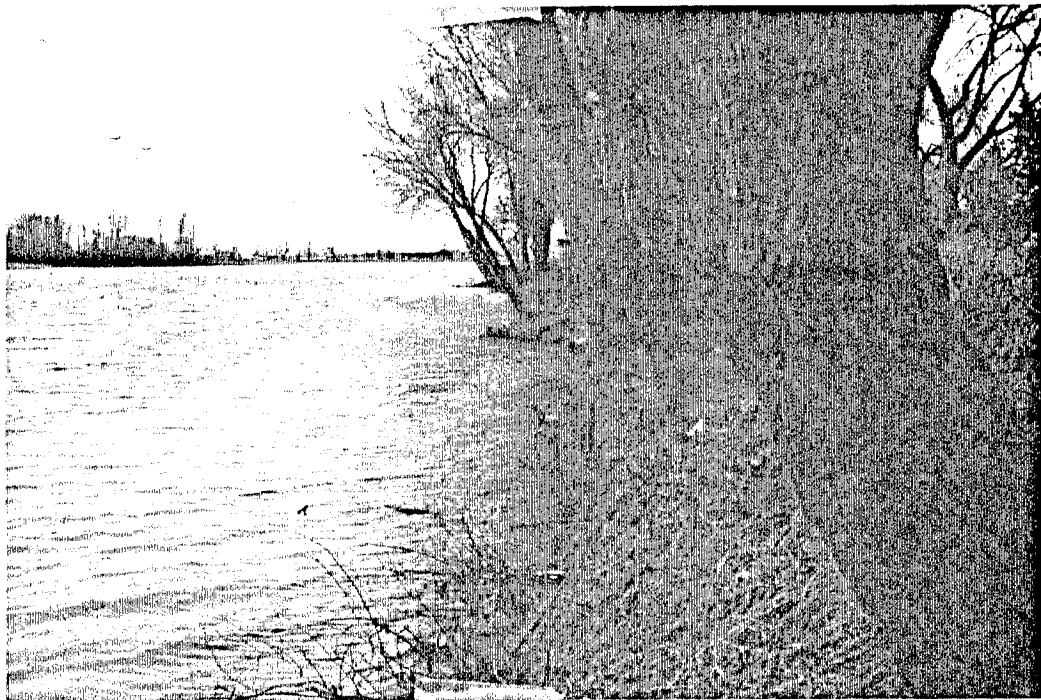
9. Looking north along east shore of east leg of lake. Slope is steep and erosion is close to trees. Would need some protection now to save the trees nearest the water.

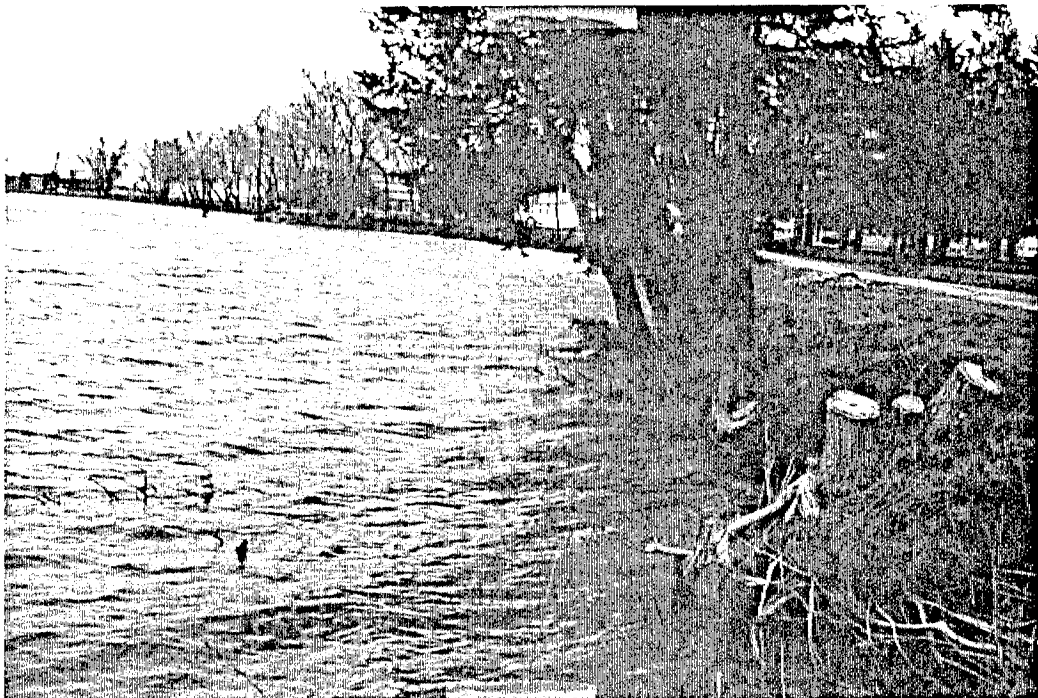
10. Looking north along east shore of east leg of lake. Active erosion in foreground and Civil Air Patrol building near center picture. Would need protection now to save some of the trees.

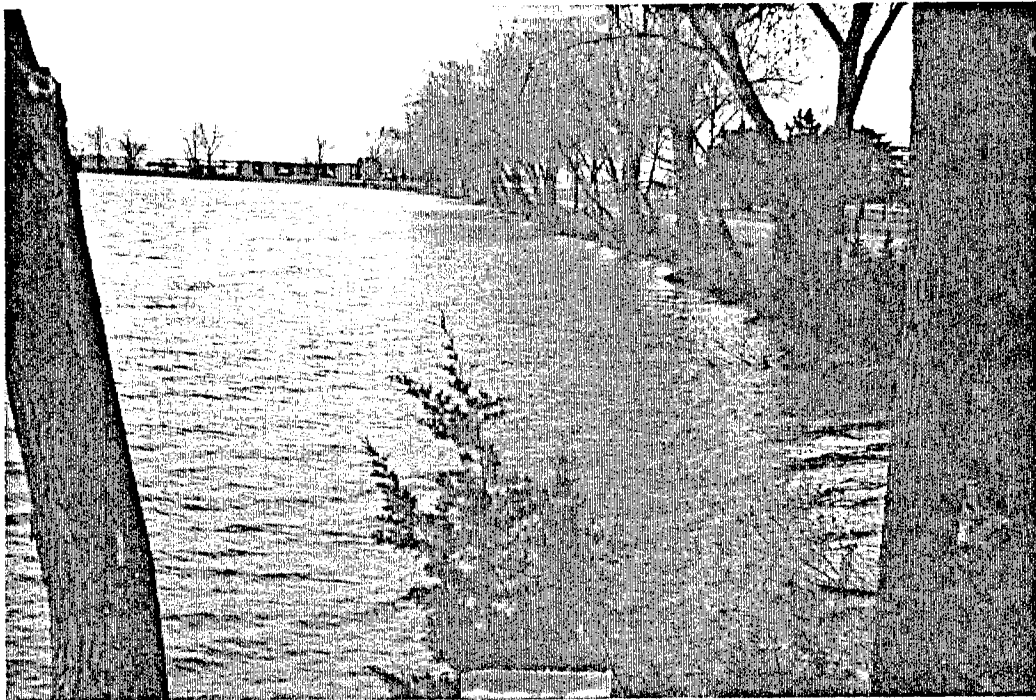
11. Looking north along east shore of east leg of lake. Active erosion along most of this reach will need protection to some trees. Public access road immediately to right of shoreline. Best Western Motel in background.

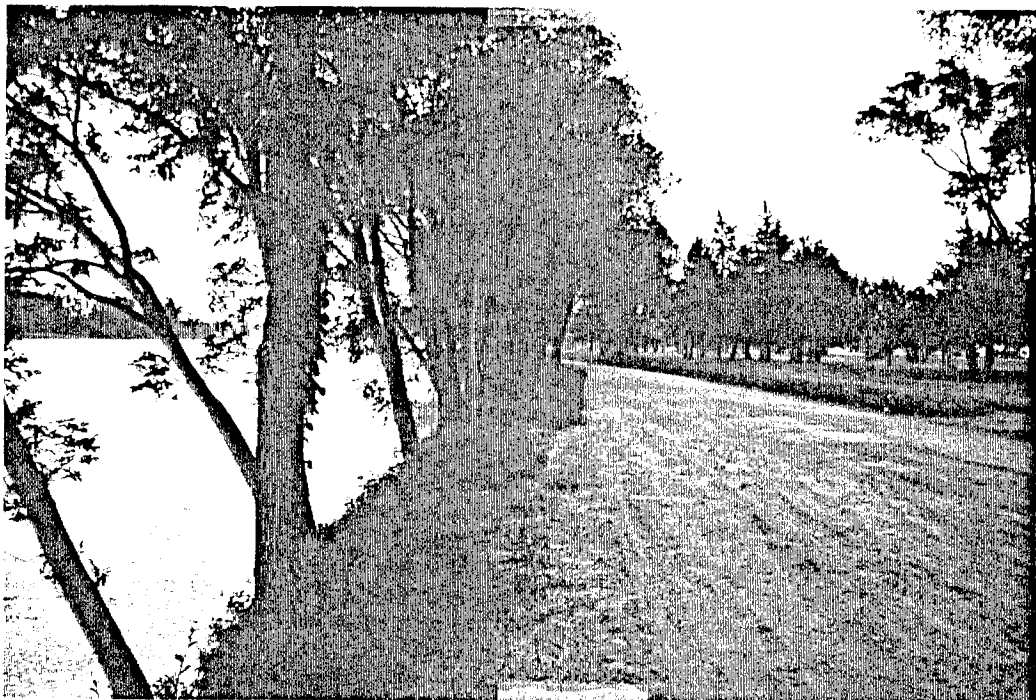
12. Looking north along public access road from same location as Photo 11. Indicates close proximity of shoreline. Trees and access road typical for this east shore of lake.

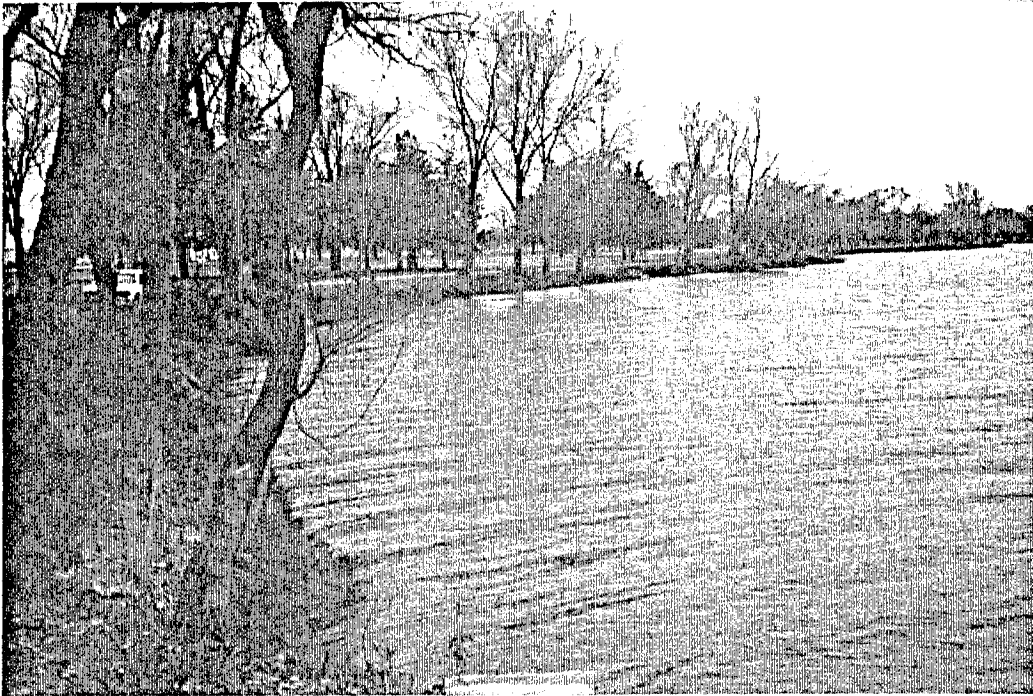
13. Looking southerly along east leg of lake. Some erosion along trees and access road.

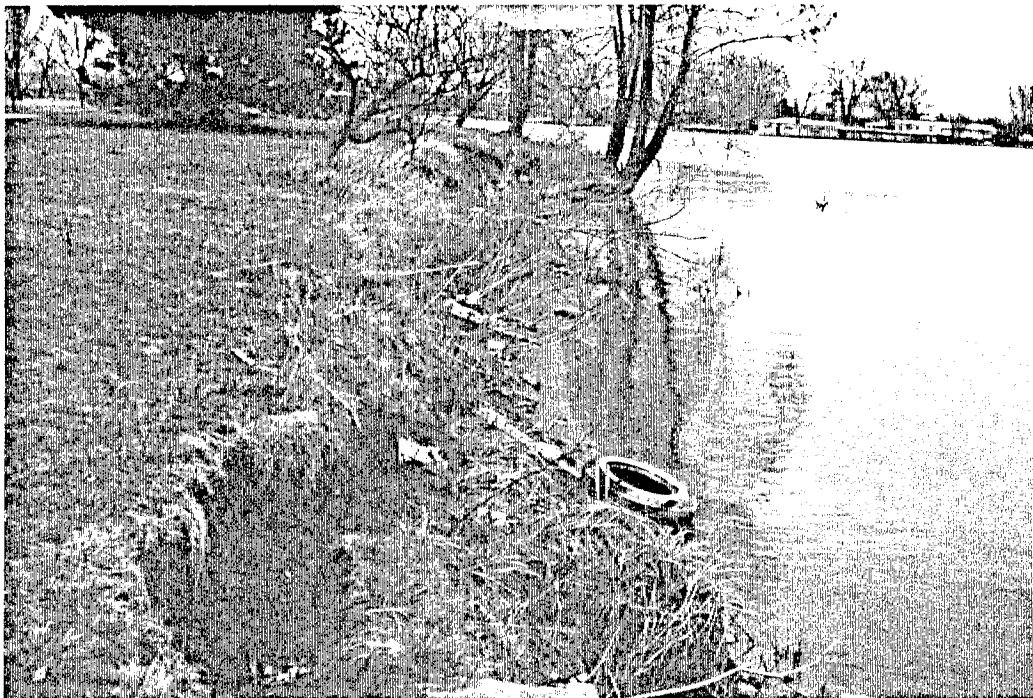
14. Looking east along north shore of lake. Active erosion. Not critical but loss of land base is occurring.
